Severe Service Journal

Volume 4 Issue 6, July 2006

DIRTY SERVICE TRIM ADDRESSES PLUGGED FEEDWATER VALVES

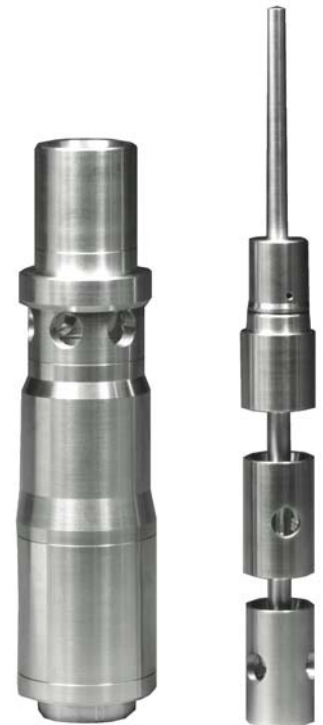
The DST design uses combined axial and radial flow paths that feature large openings, allowing for the flow of particulate up to 3/4-inch in diameter. The large passages not only allow the particulate to pass, but also eliminate the potential for velocity-induced erosion effects. The DST design also incorporates a protected seat that separates the shutoff and throttling locations. All significant pressure drop is, therefore, taken downstream of the seating surface. As a result, the seating surfaces are not worn away by throttling control action.

In order to address this issue, the plant turned to members of the Fisher Engineered Products group. Their solution incorporated large passages that allowed the entrained particulate to pass and also provided pressure staging to eliminate the formation of damaging cavitation. The Dirty Service Trim, commonly referred to as DST, has been used repeatedly in applications where plugging and cavitation control are concerns.
