Severe Service Journal

Volume 4 Issue 5 | April 2006

FISHER VALVE REPLACES WORLD'S MOST EXPENSIVE 'FLOWER POT'

MIDWESTERN POWER PLANT USES CAV4 TRIM TO AVOID RECIRCULATION VALVE LEAKAGE PROBLEMS

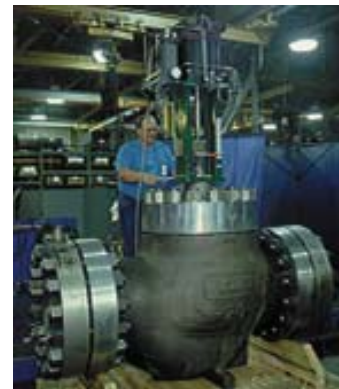
Gas-plant personnel ultimately ordered three high pressure Design EHT valves with Whisper® III noise-abatement trim to replace the two-ton behemoth and two other high-pressure valves. The Fisher® valves and their simple actuation packages have eliminated set-up problems and low lift erosion while providing a 210:1 turndown and tight shutoff, even at 3275 psi inlet!

Two years later, the Fisher valves are still operating without any problems. Pleased with their performance, the plant manager said, "I'm going to put the old, two-ton valve in front of the office and use it as flower pot . . . That is all it appears it is good for."
